AW 55-50SN / AF 23-33

Diagnosis and Valve Body Information

Presented by
Bob Warnke
ATRA Powertrain Expo 2008

Adapting to the Aisin Warner 55 50SN valve body

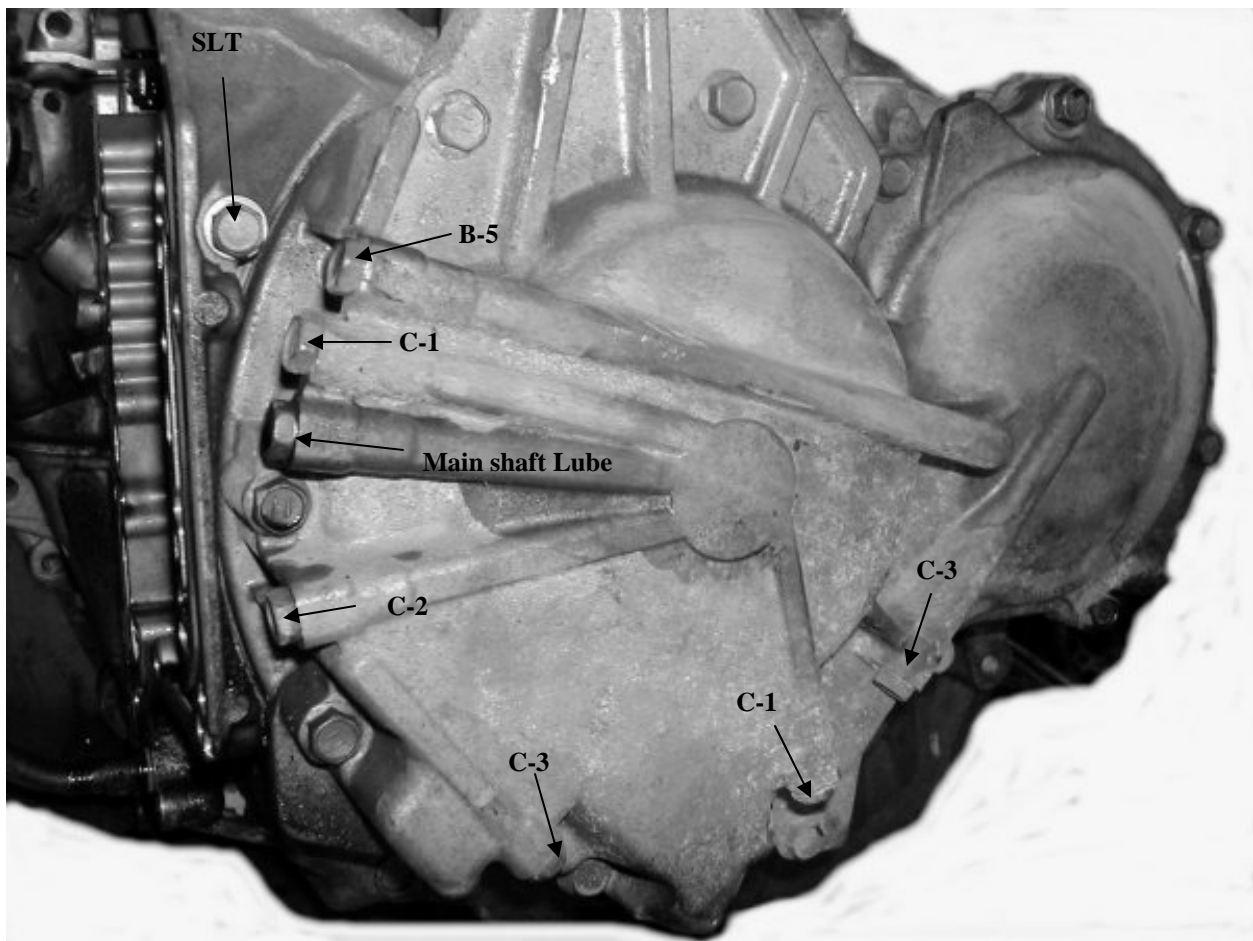
All the pressure plugs have a 12mm head. Do not mistake the 27mm band anchor (see Figures 1 and 2) for a fill plug or pressure tap. If that anchor is removed, the band will have to be recaptured. Positioning the band requires removal of the servo, at best and possibly the complete transmission.

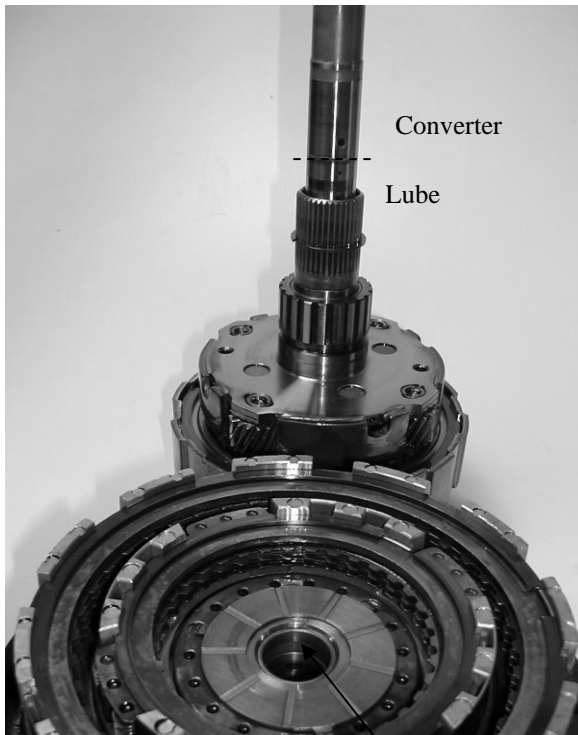
Lube pressure and flow on the 55 50SN, is low in comparison to other units. This converter requires multiple valves, along with the rear pump bushing, to control modulated TCC apply (see Figure 3). The converter clutch may remain fully applied at very low speed and high load, which taxes the fluid and lining, creating a break-away slip or RPM fluctuation.

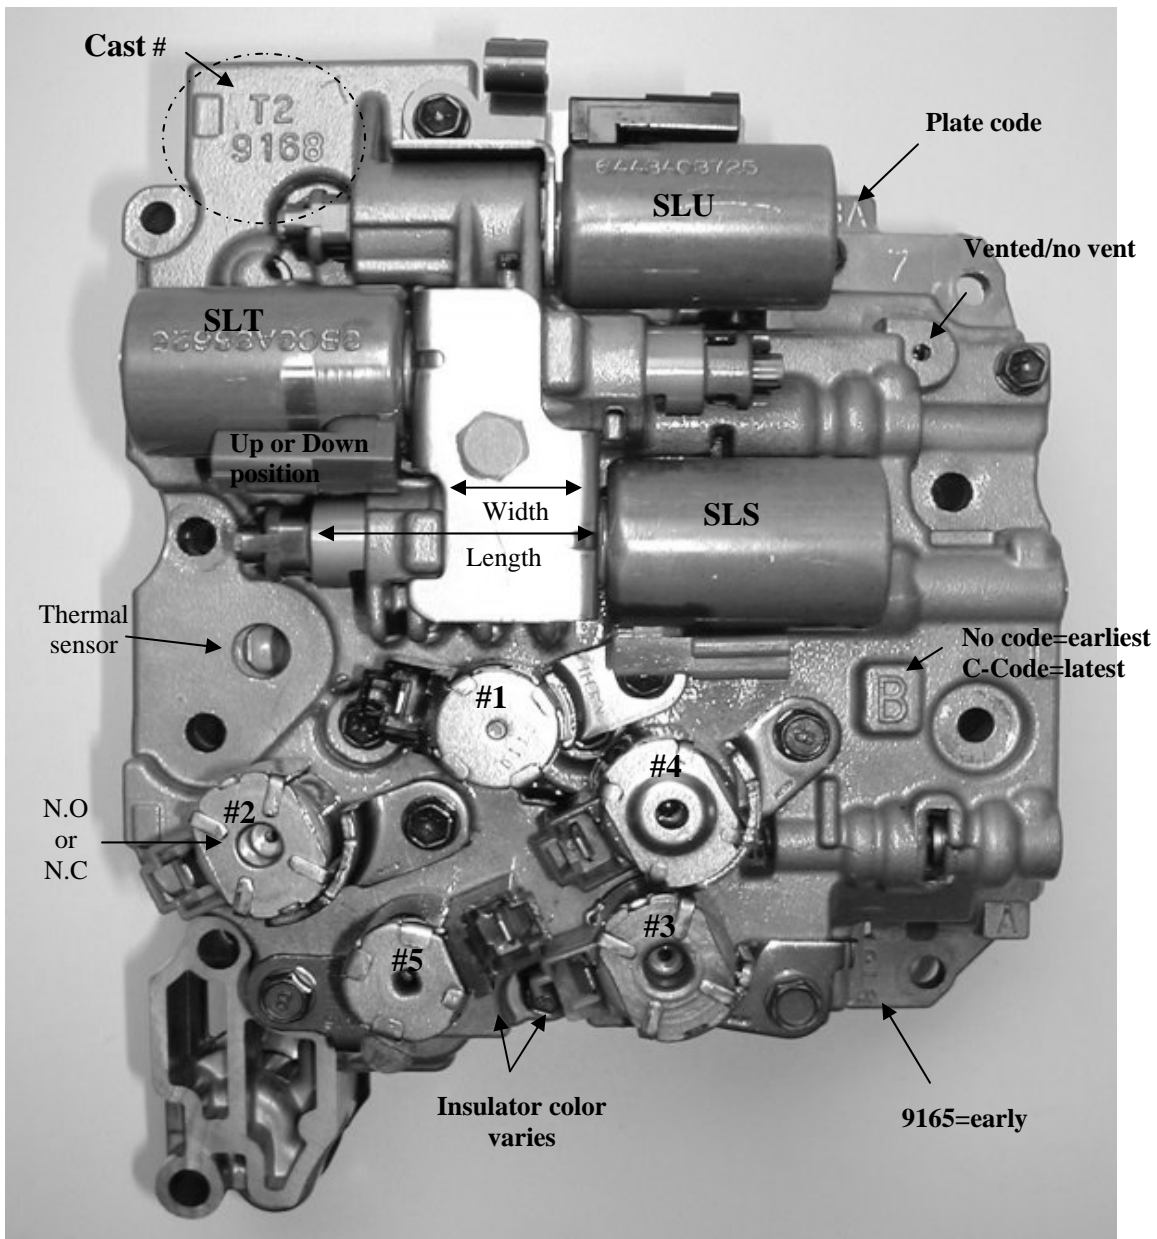
You can perform a similar air test (ill#4) with the valve body itself. When doing so, the pump line port and thermal element hole must be closed and the separator plate held as shown to eliminate cross leaks. This might sound confusing in print, but when you do it, the ports will be evident and easy to close with an opposite hand.

If you pressurize the SLT port with shop air (80-100 psi), air pressure will push fluid, which you see as a leak. Problematic leaks occur at the steel side cover, SLT accumulator, B-1 and C-1 control valves. A major leak or combinations, cause delayed engagement or flare up-shift and should be inspected after disassembled.

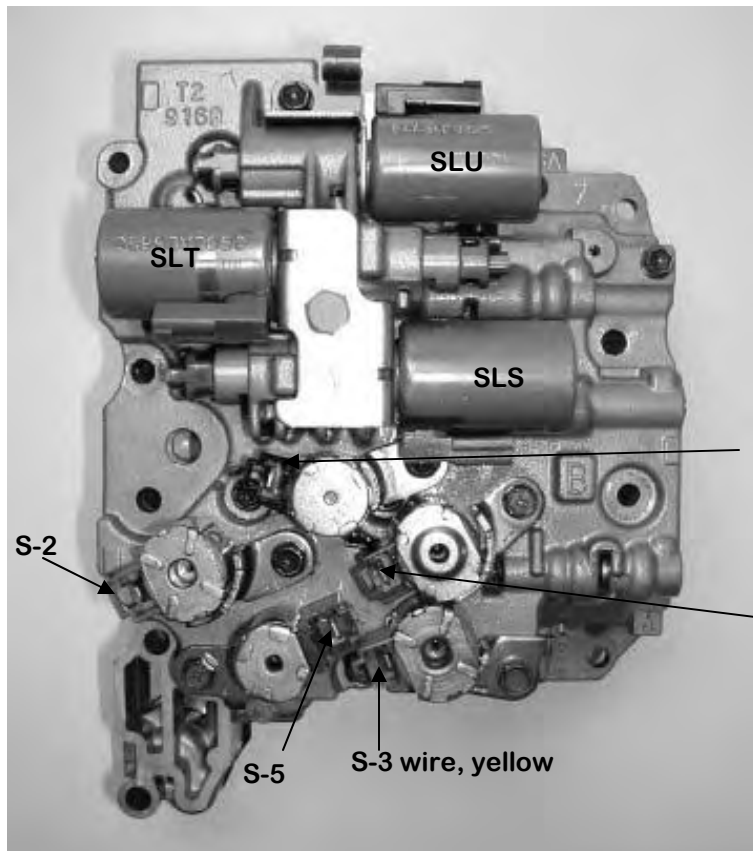
- Wiring Issues (see photo left)**
- Common to mix up connectors from harness
 - S1- White wire, right side loom.
 - S3- Yellow wire, left side loom.

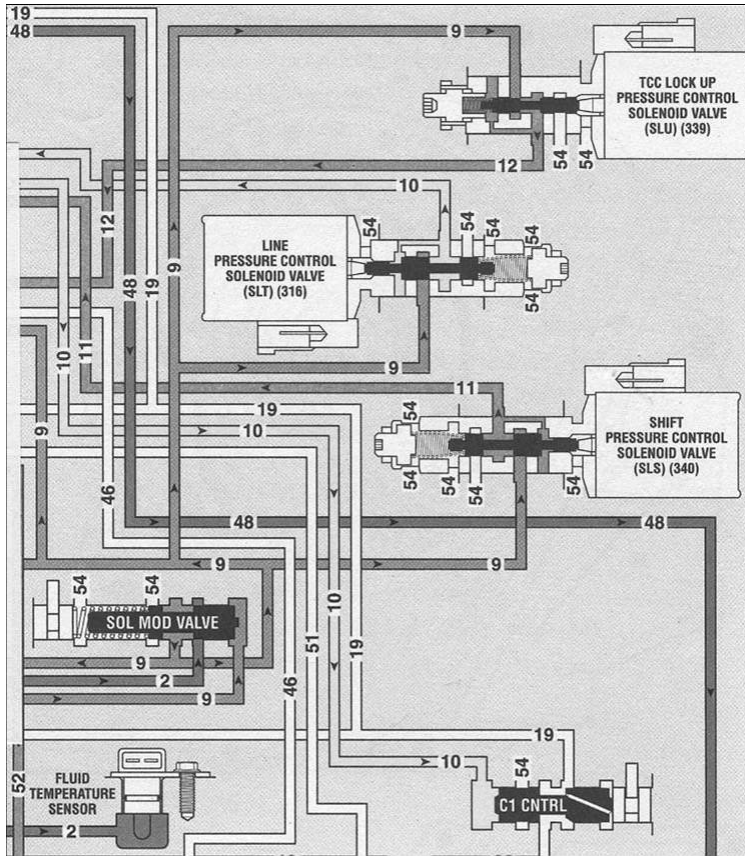
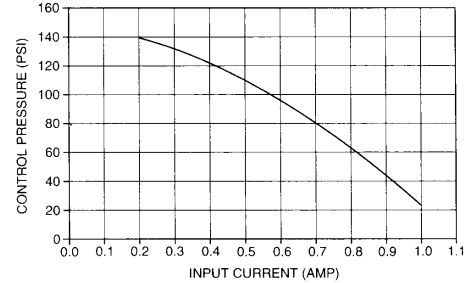
SL Solenoids

LINE PRESSURE CONTROL SOLENOID VALVE CURRENT FLOW

Note: This OE chart is referring to line pressure. Actual SL output is limited by solenoid modulator valve to 80 psi.

Measurement:
End of solenoid manifold to shoulder on adjuster

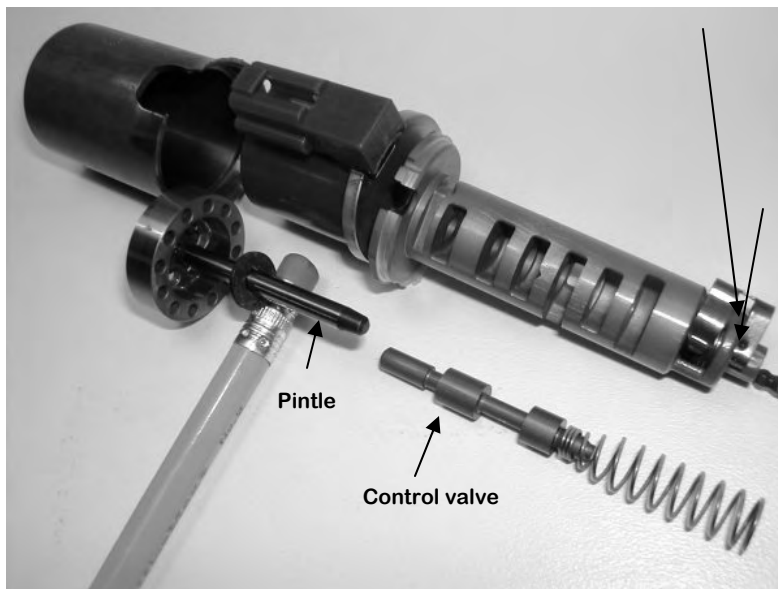
SLT-SLS
Preliminary adjustments: .010"-.050", record prior to removal.
Measurement taken with retainer removed. Shoulder of adjuster to end of manifold.
Turning screw inward, raises SLT & SLS pressure
6 clicks = 1/2 turn.
Turning screw inward, reduces SLU
6 clicks = 1/2 turn.

- Adjustment clicks are created by the increments on exterior of threaded allen, 3mm
- With control valve removed, shaking the coil should result in a free pintle movement.

All solenoids are 5.0-5.6 ohms and operate at 300Hz. Between 10 and 40% duty cycle.
Note: Bracket changes on Linear solenoids. Length of Linear SLT-SLS varies.

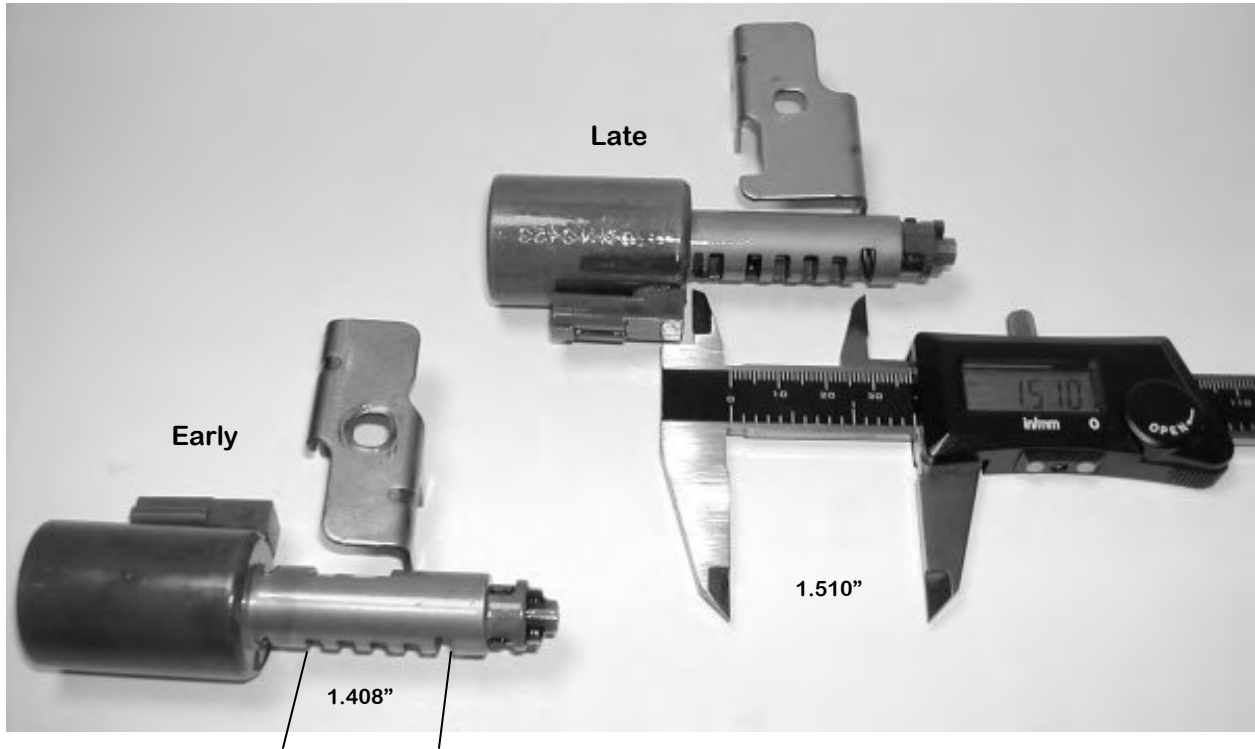
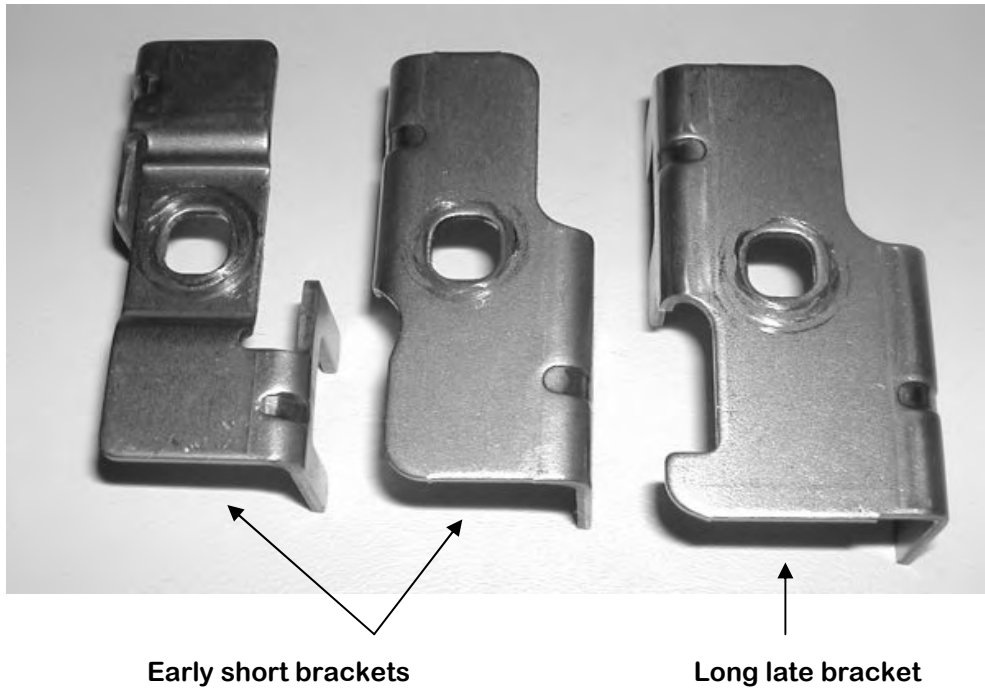
SLU-Remains same Early-Late

SLT-Early

- Slot for bracket results in solenoid connectors upward.
- Bracket is narrow type
- Distance bracket slot out ex. 1.408" (short manifold)

SLT-Late

- Slot for bracket results in connector down
- Wider bracket
- Long manifold 1.510"
- Connector down requires special harness, Volvo update.

SLS-Early

- Slot for bracket requires connector up.
- Narrow bracket
- Short manifold 1.408"

SLS-Late

- Slot for bracket requires connector up.
- Wide bracket
- Long manifold 1.510"

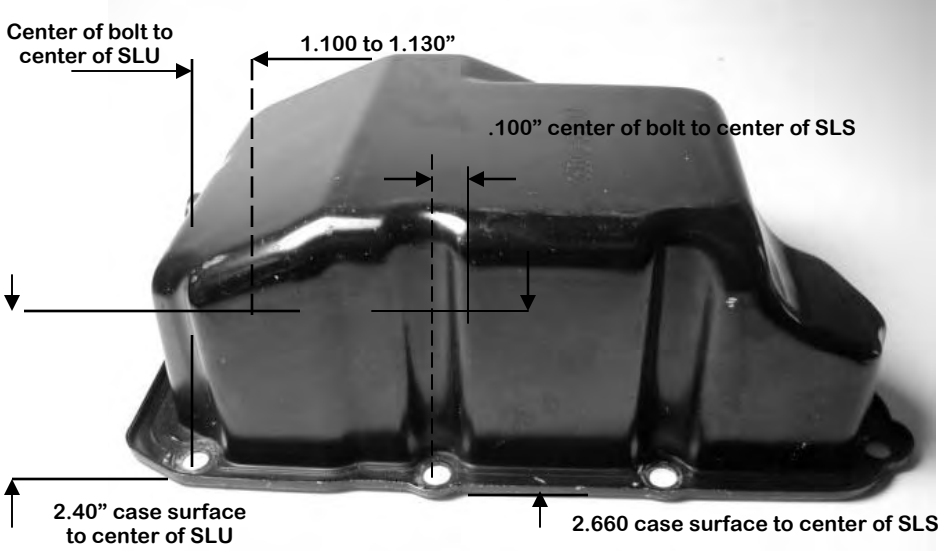
SL Solenoid Access

The side cover can be drilled and plugged to adjust the linear solenoids. Cover must be removed for this procedure!

Hole size depends on what plug you use. 1/4" blind head rivets are an option. Seal with silicone upon install.

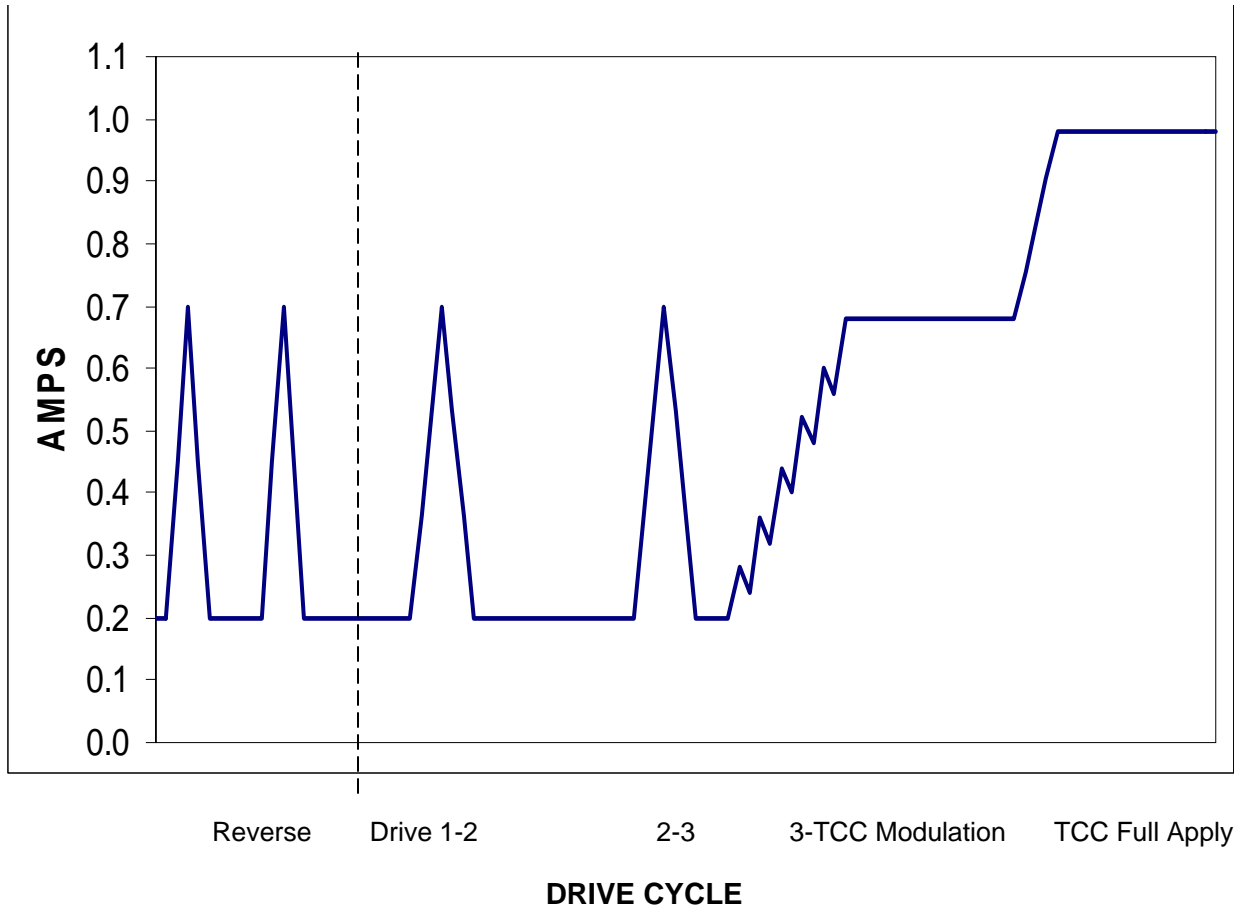
SLU SOLENOID

High current causes high pressure
 Solenoid is Normally closed (N.C.)
 300 Hz operating frequency 15%-48% duty 1 AMP, TCC is off.
 SLU controls 2nd clutch (B-2) and low reverse (B-3). Manual low for engine, braking
 SLU- Has been know to create 1-2 slip, 2-1 harsh downshift if not adjusted or defective. It also can over heat fluid and affect TCC apply.
 SLU generally controls TCC right after 2-3, and will maintain TCC apply coasting or cruise at 25 mph.

Chart Example: '03 Volvo V70 XC

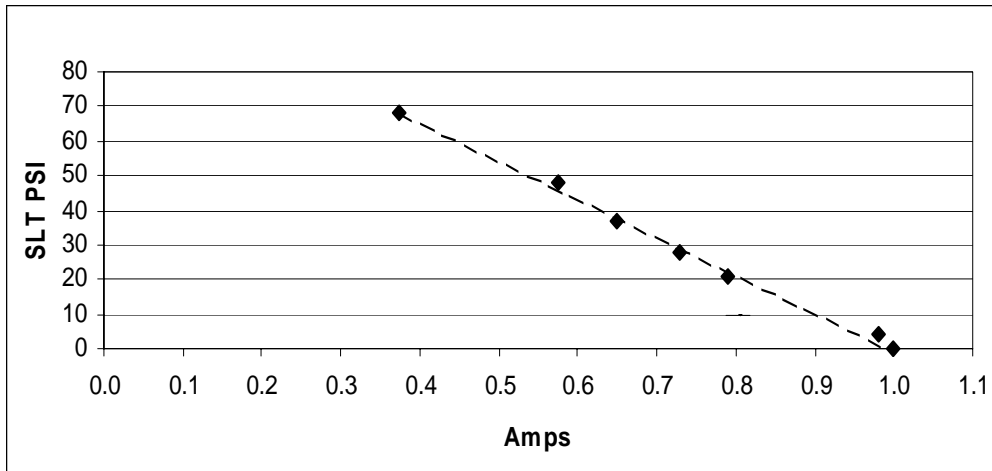
SLT SOLENOID

300 Hz operating frequency 15%-48% duty
 SLT is normally open solenoid (N.O.)
 Low current causes higher pressure (inverse proportional)

Chart Example: '03 Volvo XC 70 Vehicle data

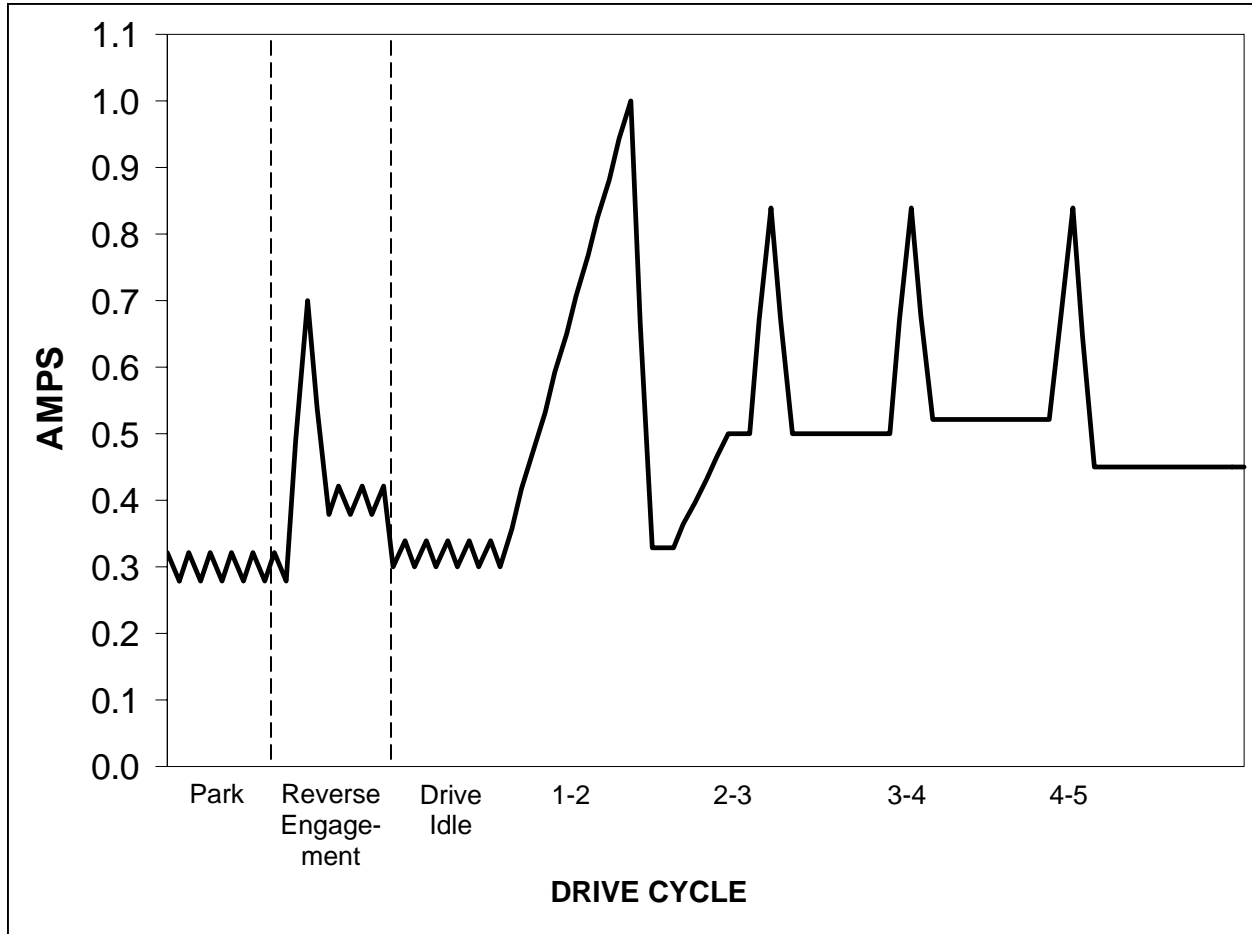
SLS SOLENOID

300 Hz operating frequency @ 15-40% duty

SLS is normally open solenoid (N.O.)

Low current causes higher pressure (inverse proportional)

This solenoid is spiked to increase clutch feed, then modulated between shifts.

Coast down shifts are modulated also with a pressure rise after each shift.

SLS controls: 2nd, 3rd, 4th, B-1 brake, 5th, Reverse, C-2 clutch

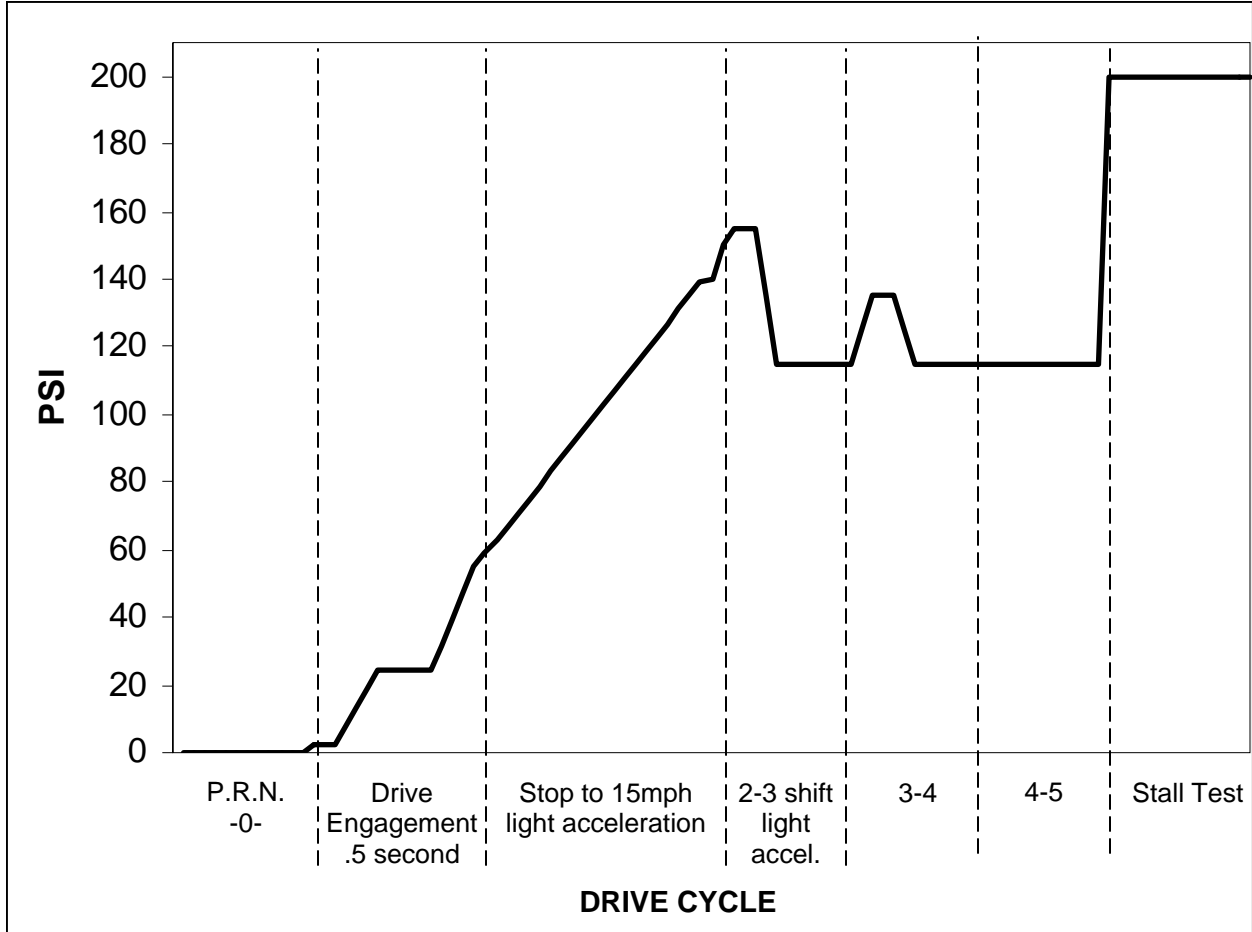
C-1 CLUTCH PRESSURE

Note: If C-1 pressure upon initial engagement is 160 instead of the 50-60 psi, the TCM has commanded a pressure rise. Verify with SLT amperage, then check for codes and electrical issues.

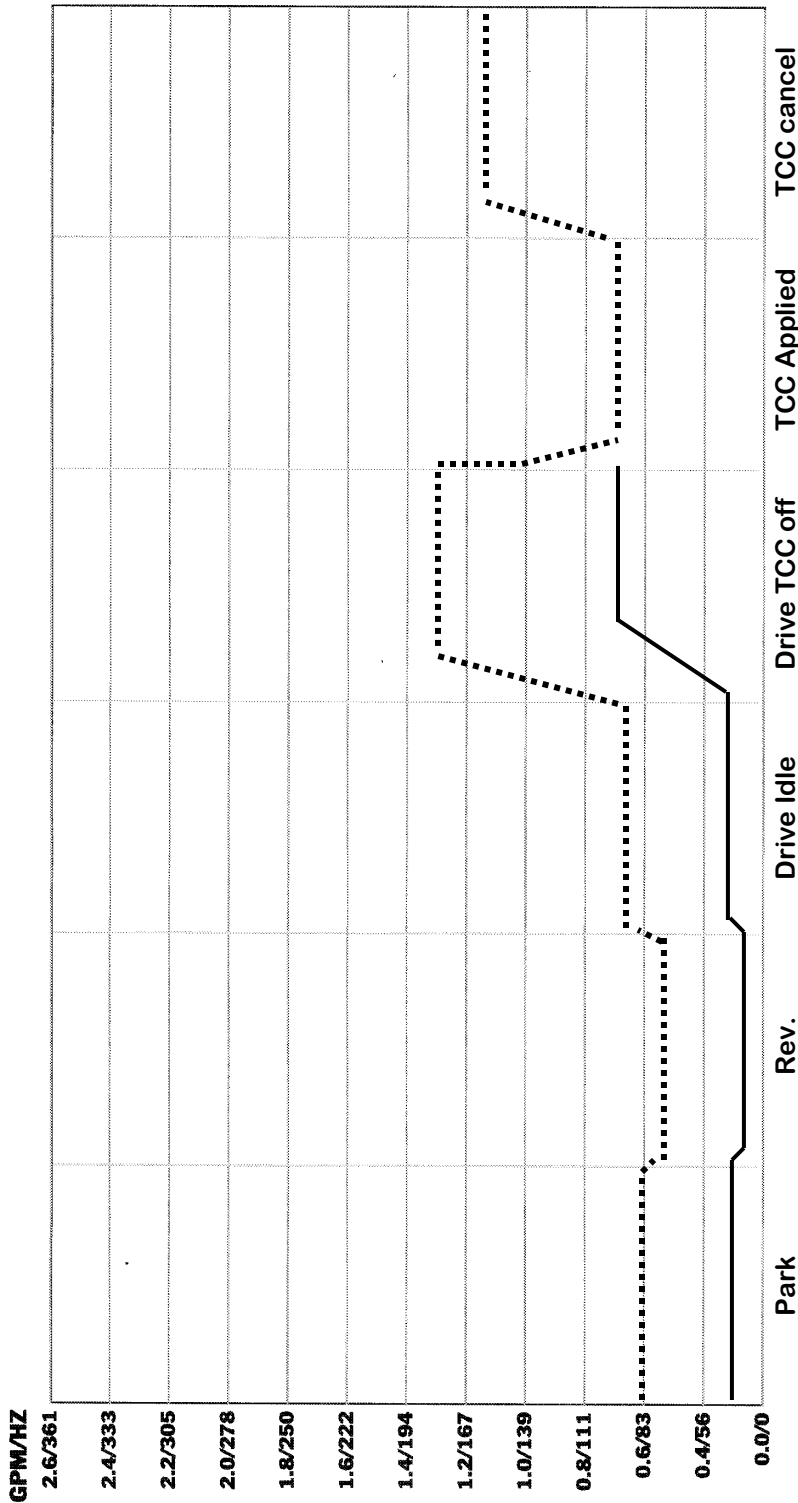
APPLICATION: 55 50 SN &/or AF23/33 Volvo '02 (130,000 m)

Event: Normal conditions

Condition: Cooler flow — 8°F Cooler flow 150°F

Lube pressure: 8° F 12 psi P 150° F 9.0 psi P
 OEM: 8° F 34 psi Revs. 150° F 9.2 psi Revs.
 Cooler lines: 8° F 24 psi Drive 150° F 6.0 psi Drive

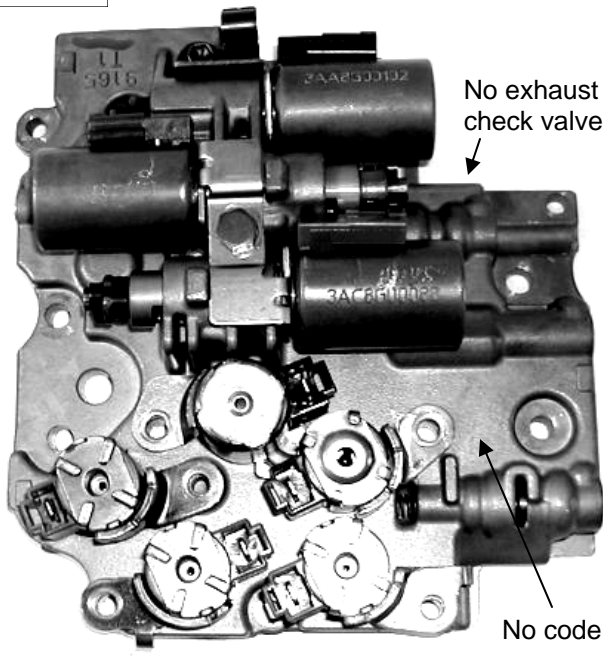
Fig. 1

This casting does not match the GM AF-23 oil circuits in Blue Technicians guide.

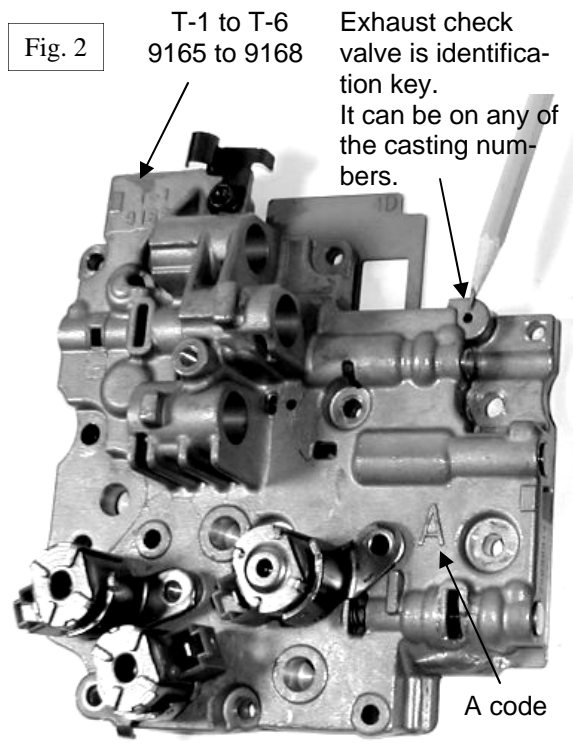
Fig. 2

Code: No = Early
C is late

Typical of the updated Volvo, C valve body

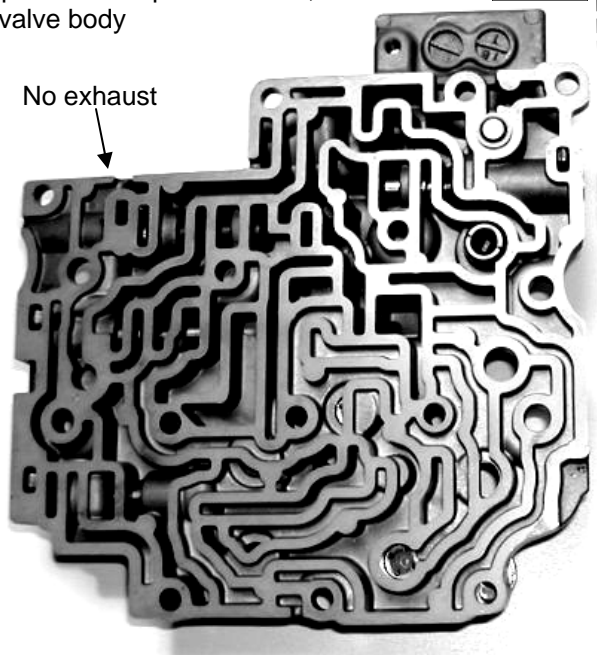
Fig. 1

Exhaust Casting matches GM AF-23 Technicians guide oil circuits.

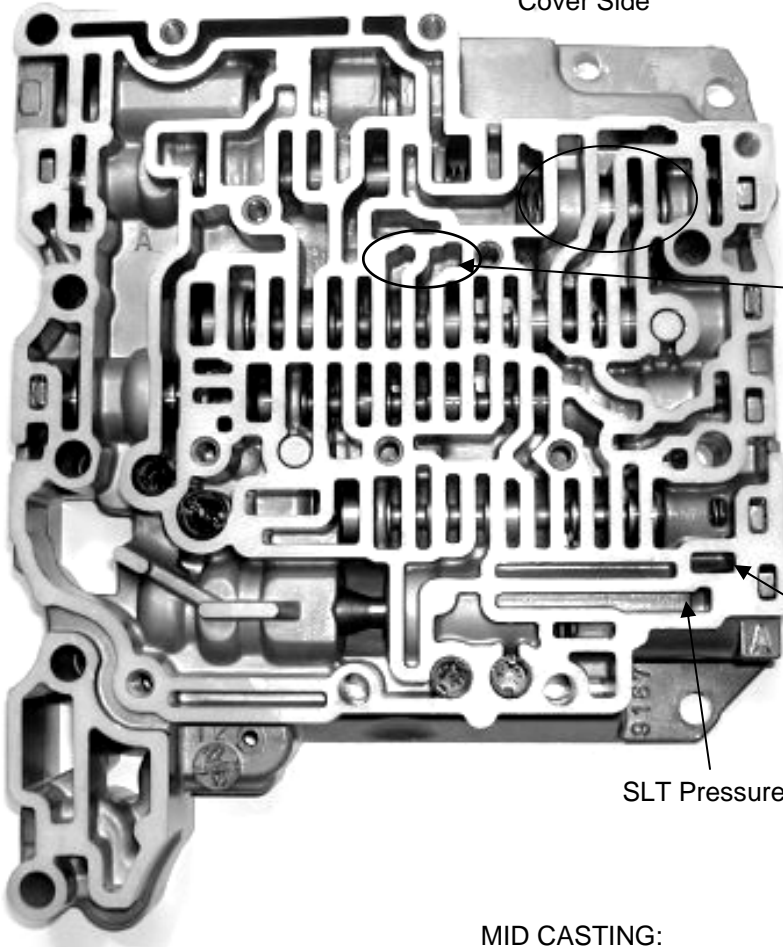
MID-CASTING:
Cover Side

- Inspect for visible wear & scoring.
- Vacuum Test, minimum of 18" vacuum.

This casting (two flags):
Must go with exhaust type
plate and front control.

*One flag on right only:
Assembles with a non-exhaust
plate & front control.

Boost sleeve vacuum test

SLT Pressure

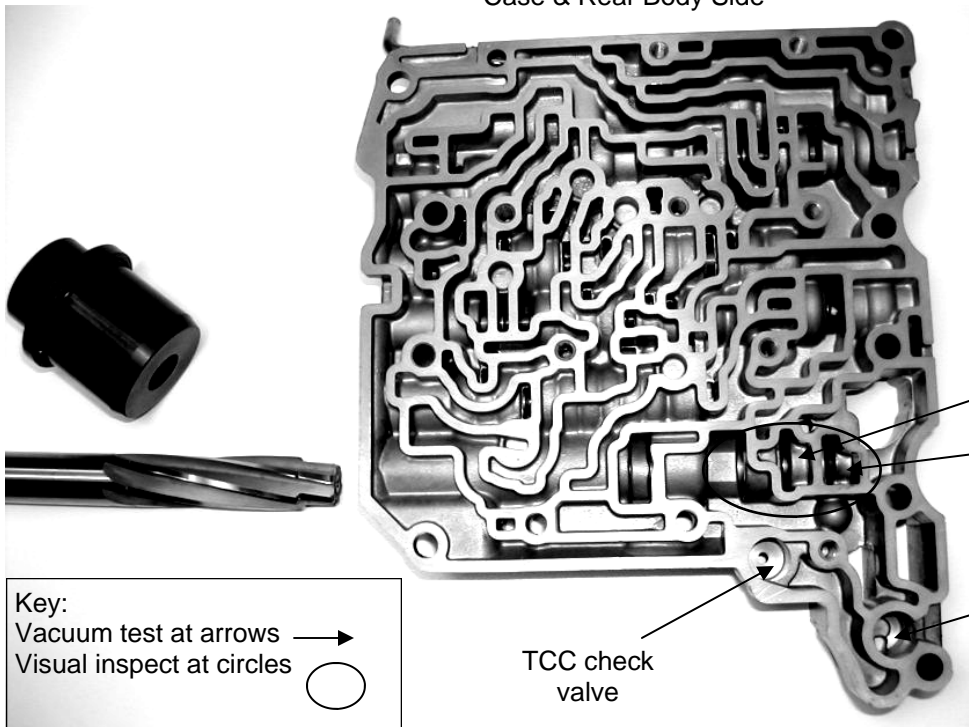
MID CASTING:
Case & Rear Body Side

Vacuum test for
pressure
regulator valve
bore wear.

Cooler bypass.

TCC check
valve

Key:
Vacuum test at arrows →
Visual inspect at circles ○

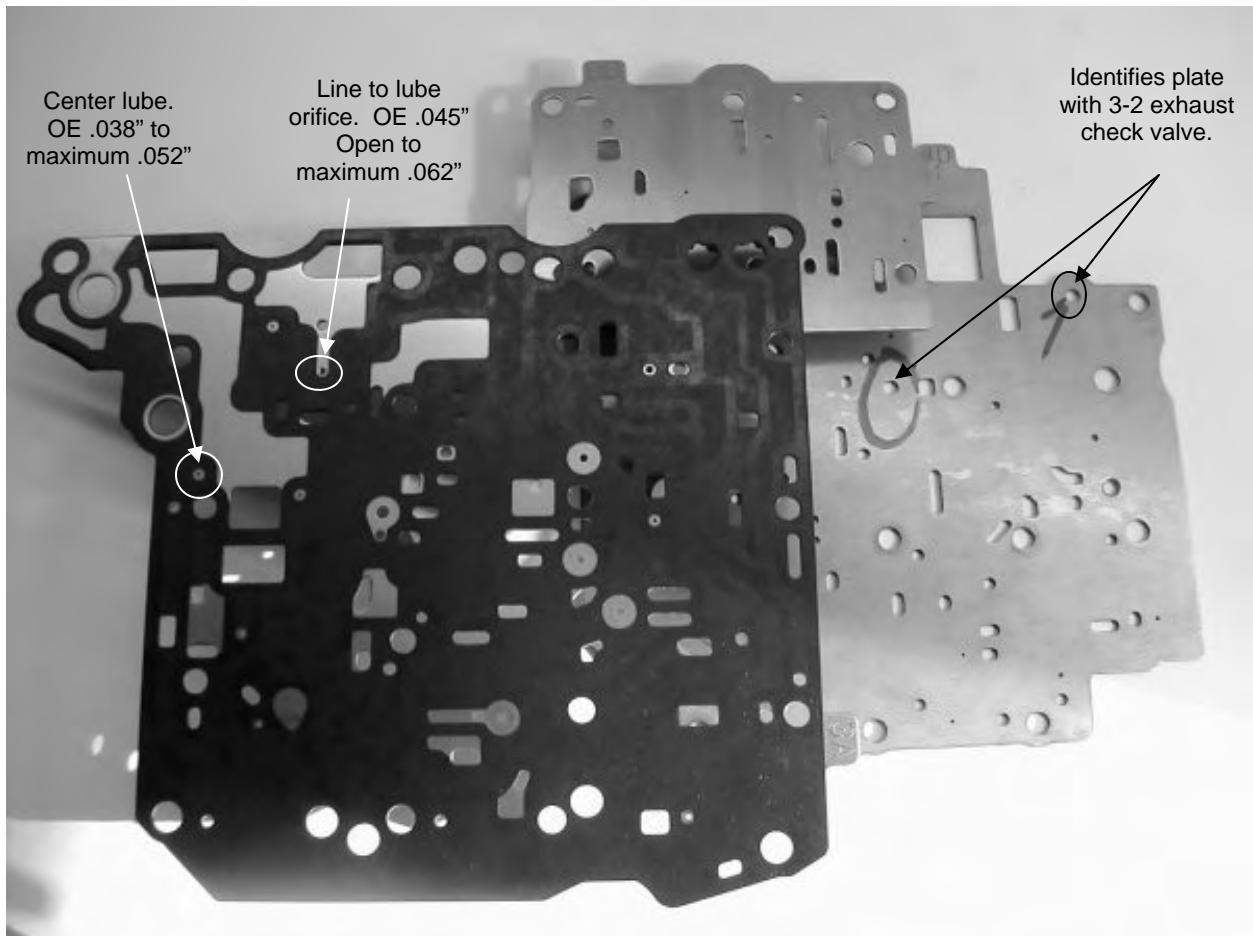
Separator Plates

Plates must match the top & middle casting

A separator plate modification can be performed, if the secondary regulator bore has minimal wear. This modification will increase lube and converter feed oil flow. Enlarging the plate feed holes is not suggested if the valve body casting has excessive wear at the secondary regulator bore, in the area of the spring to spool surface.

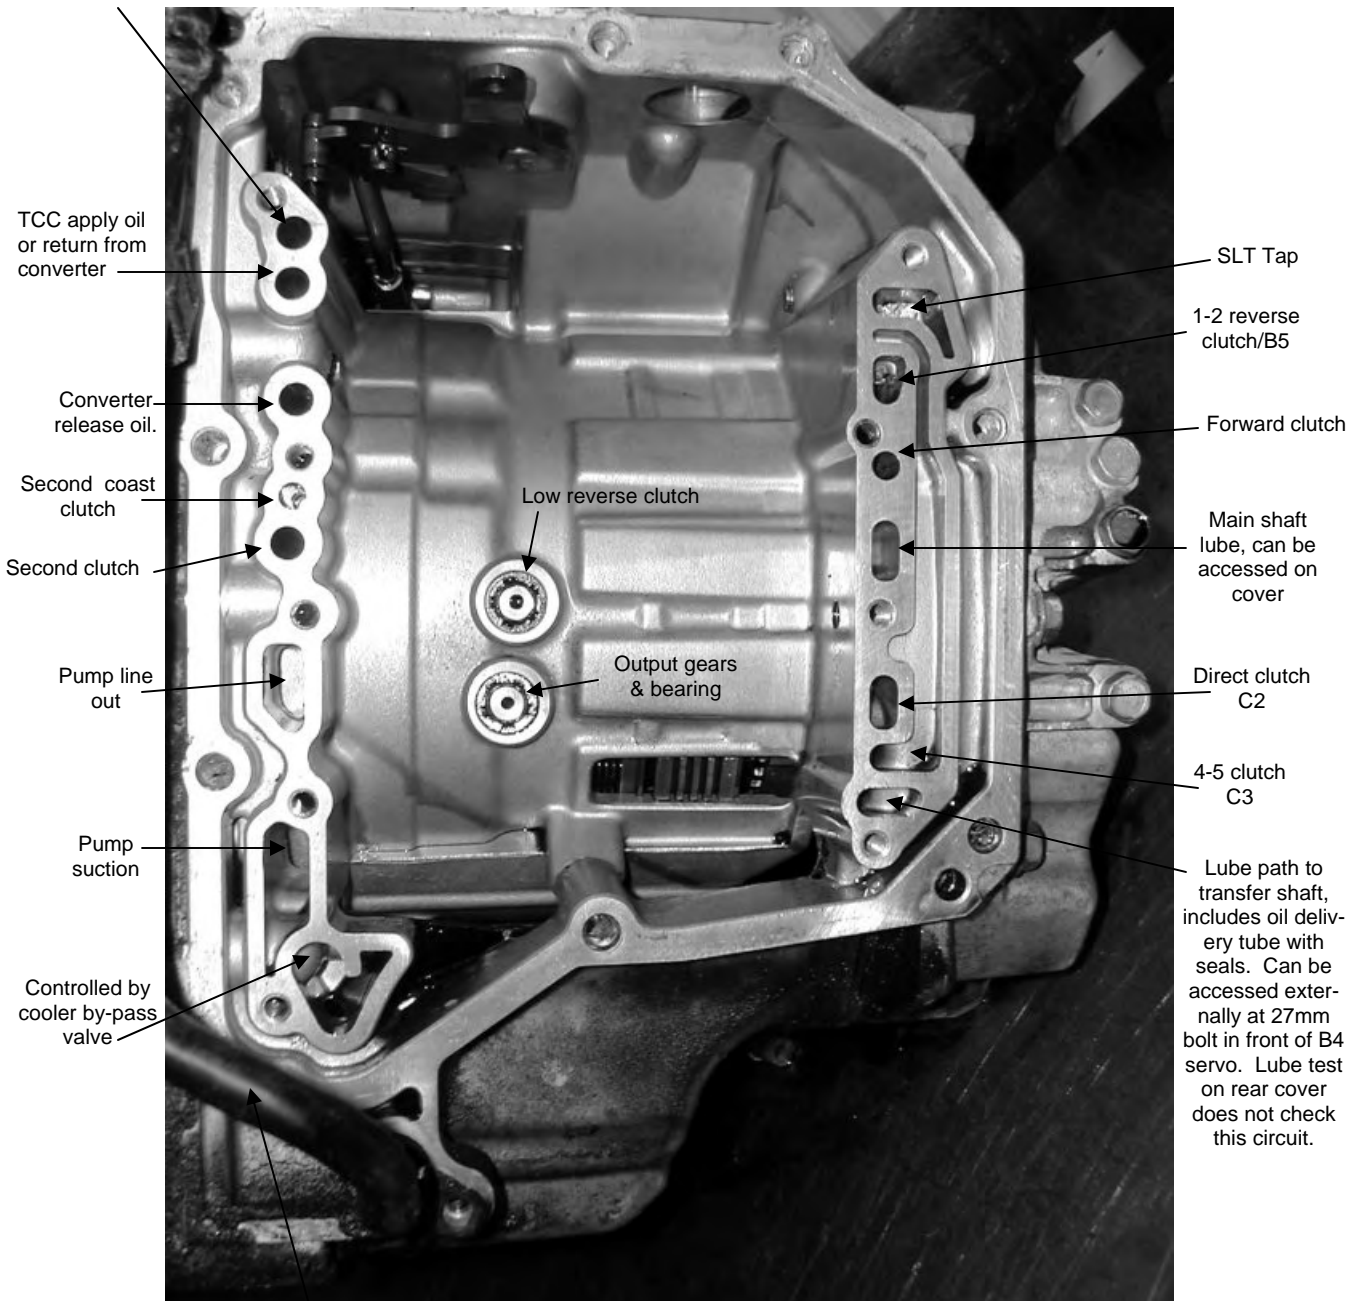
Volvo pictured
 Converter out line to cooler. Cooler returns into valve body cover.

AF 23/33
 Left side is converter out, right is return to sump.
